Inspection Report

Property Address:
200 Pleasant Street
Hometown RI 02837

Hearthstone Home Inspection

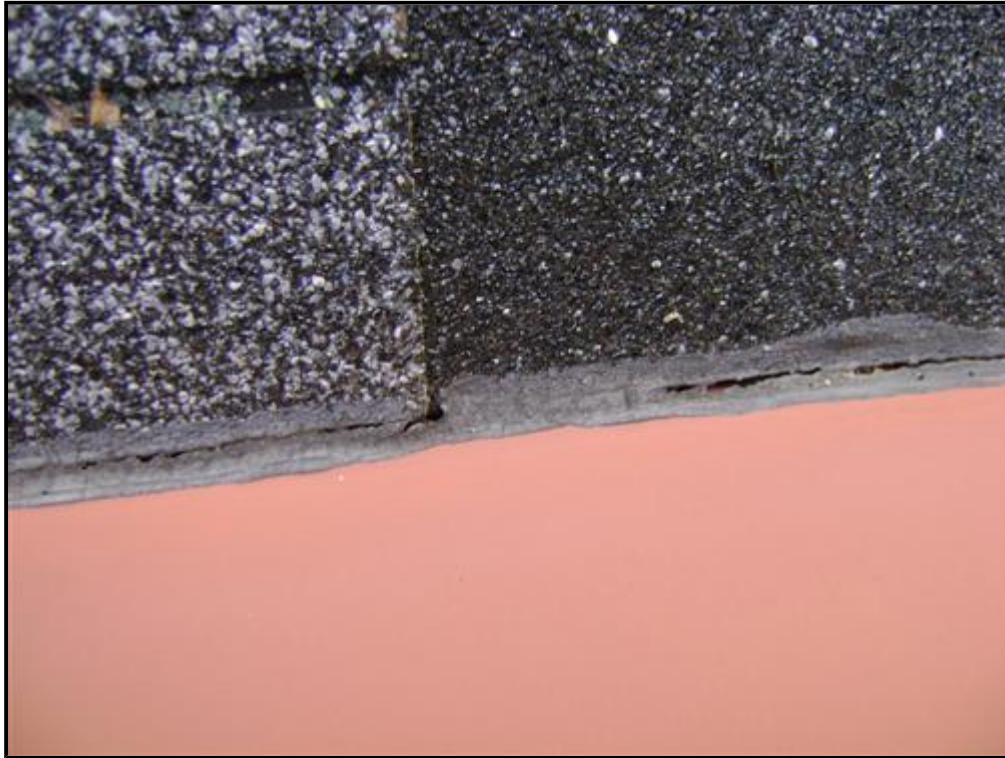
There is some blistering on the tar and gravel roof over the kitchen area. The rolled roofing over the front entrance is deteriorated and cracked. The scuttle opening through the roof does not appear to be properly secured through the roof (no visible flashing or other means to prevent leaks). There is caulking on the outside of the scuttle which has separated/cracked. I recommend evaluation and repairs by a roofer.

1.0 Picture 2 Openings in caulking and no flashing around scuttle

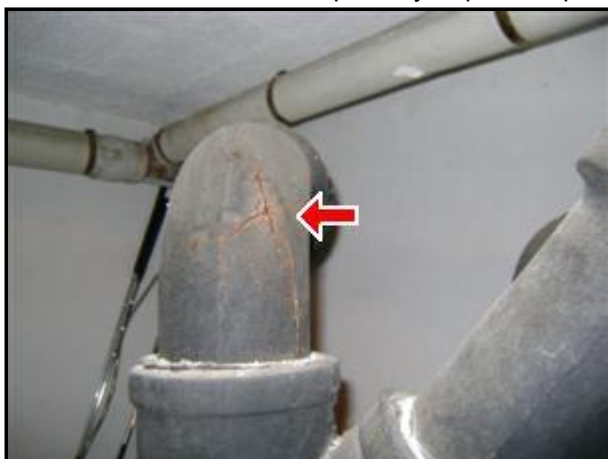
- There are cracks in cast iron waste lines in the basement and uncapped waste lines in the basement. I recommend evaluation and repairs by a qualified plumber.

6.0 Picture 1 Cast iron waste line in basement.

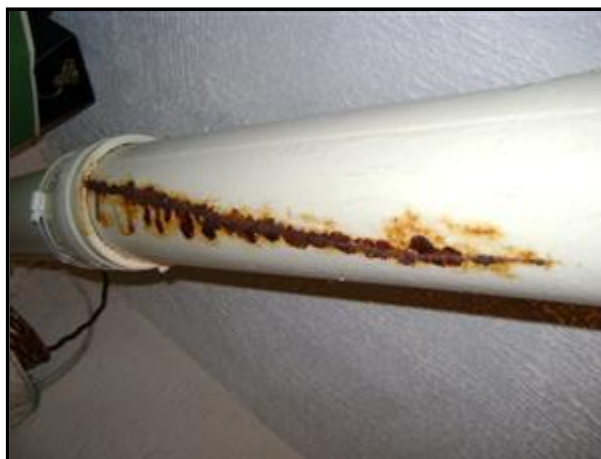
6.0 Picture 2 Cracked waste line in basement.
